Landslide Risk Assessment 2026 Update

Project 0404103
Document Rev 0

District of North Vancouver
355 West Queens Road
North Vancouver, BC V7N 4N5

Landslide Risk Assessment – 2026 Update

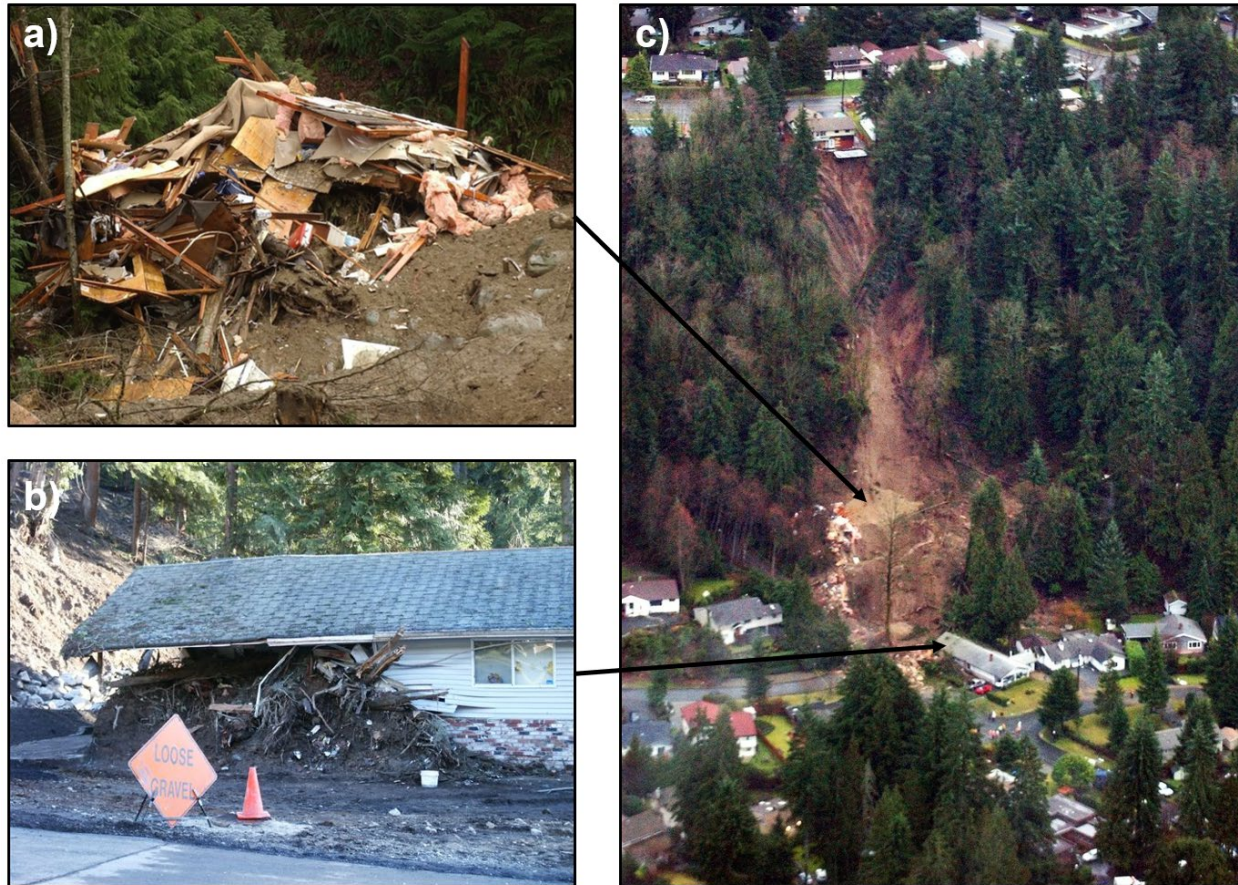
Figure 3-3 Building damages from the 2005 Berkley Landslide. a) Completely damaged house at 2440 Chapman which had 1 fatality and 1 serious injury (source: Ian Smith/Vancouver Sun). b) Partially damaged house at 2290 Chapman Way with 0 fatalities and 5 survivors (source: BGC). c) Overview of the landslide path (source: Ian Lindsay/Vancouver Sun).

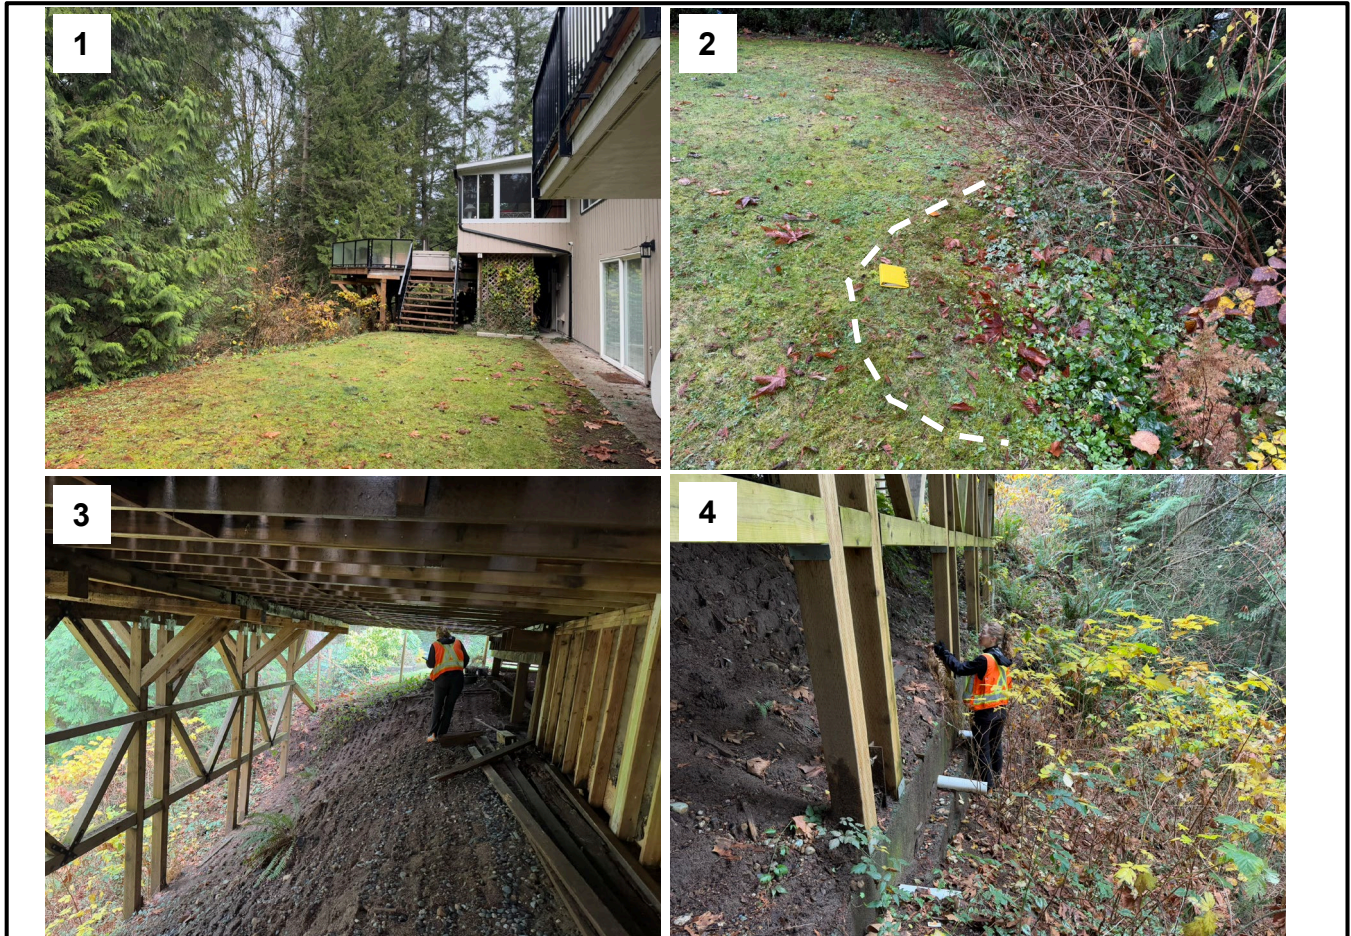
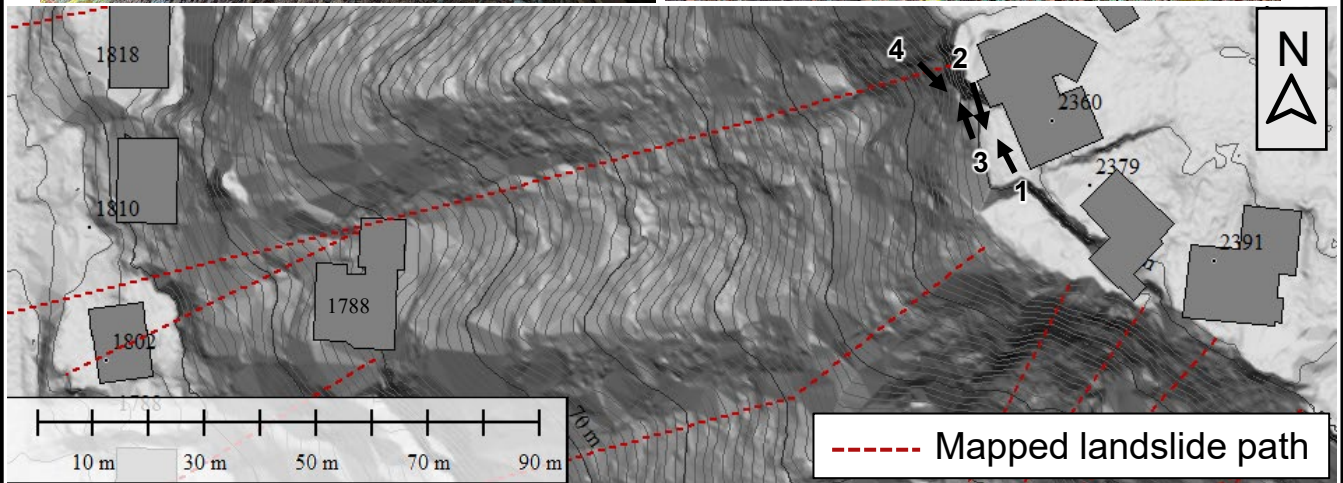
PREPARED BY: LCH	FIGURE TITLE: 2360 Carman		
CHECKED BY: SZ	CLIENT: District of North Vancouver		
APPROVED BY: LCH	SCALE: N/A	PROJECT NO: 0404103	FIGURE NO: C-1

- Backyard sloping gently towards slope. Area of minor slumping (<1 m², <0.1 m deep depression) at crest (Photo 2), south of historical 1979 headscarp.
- Mostly straight trees with some pistol butted alders. 1979 slide path vegetated with young alders.
- Concrete retaining wall with drainpipes supporting wooden deck at 1979 headscarp location (Photo 3,4). Appears to be in good condition at time of inspection.

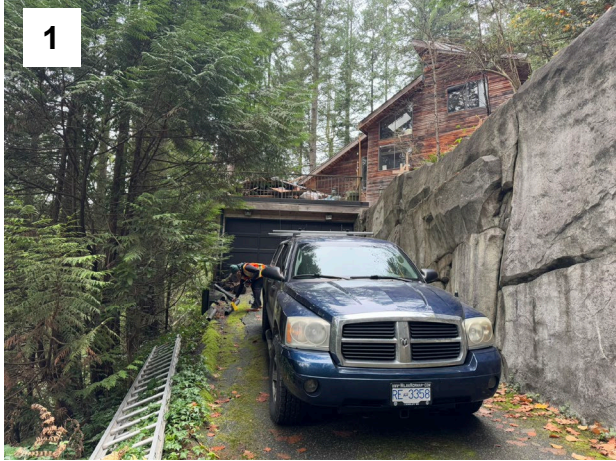
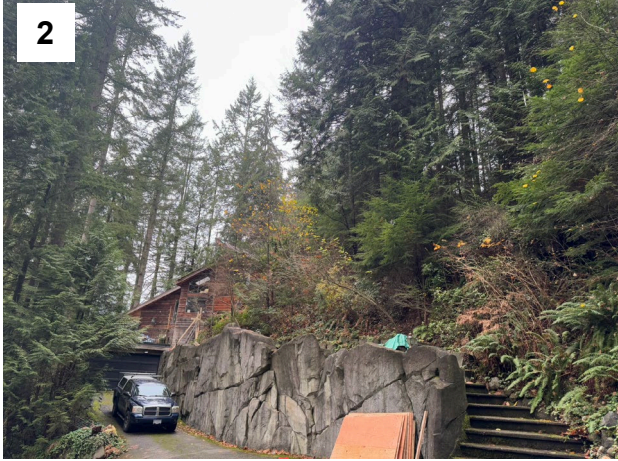
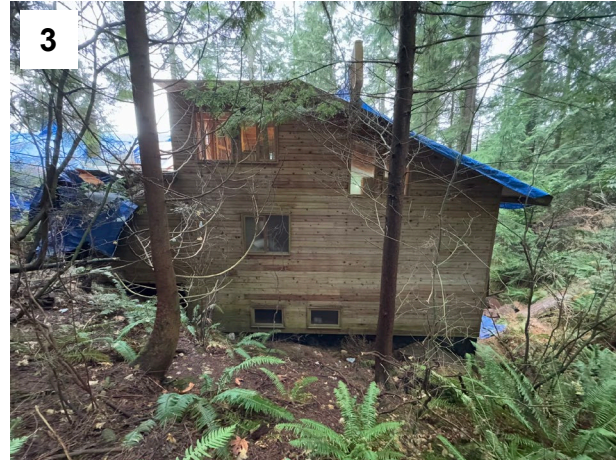
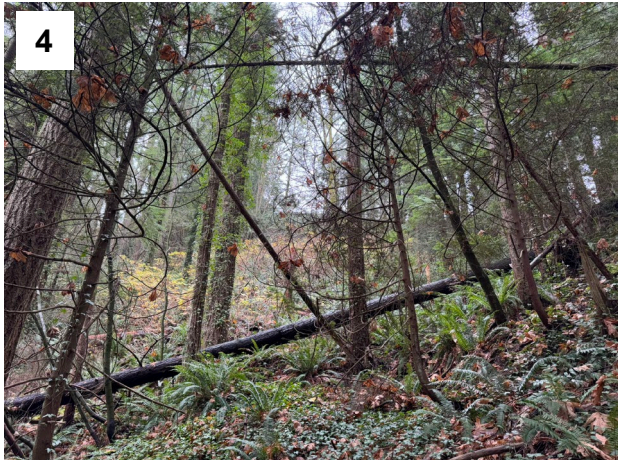
C-2

- Cracks observed parallel to slope in driveway. Existing retaining wall at driveway in robust condition.
- Building in natural gully that includes the 1979 slide path. Large conifers observed in gully.
- Northeast corner of building exposed to landslides from 2360 Carman (Photo 3). Southern portion of building footprint protected by ridgeline.

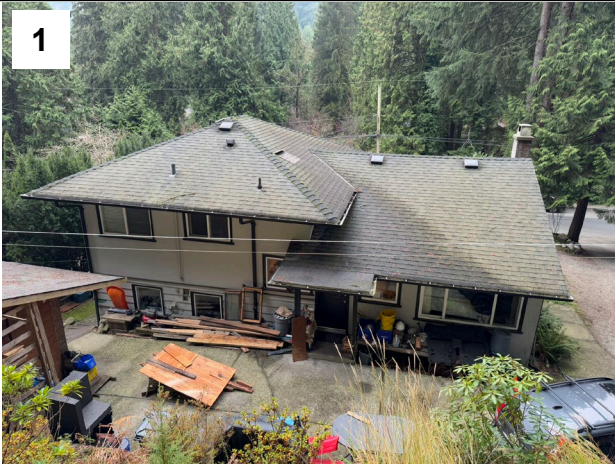
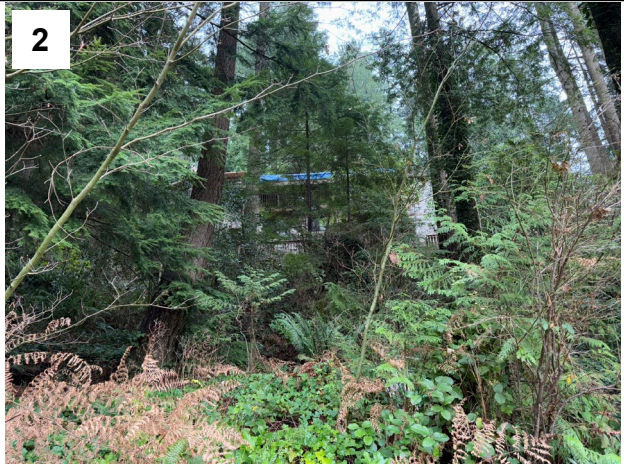
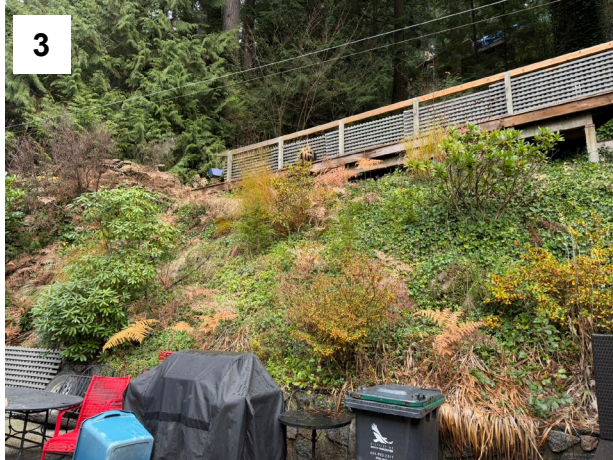
C-3

- Property downslope of 1788 Riverside. Gentler slope upslope of retaining wall.
- Landowner reported having a test pit completed in upslope area and indicated dense material was observed approximately 18 inches below ground (BGC does not have access to log to confirm).
- Landowner reported that stone retaining wall seeps in heavy rain.

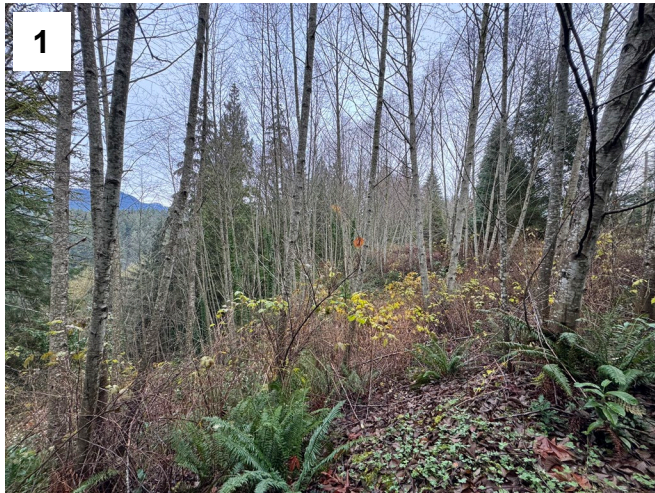
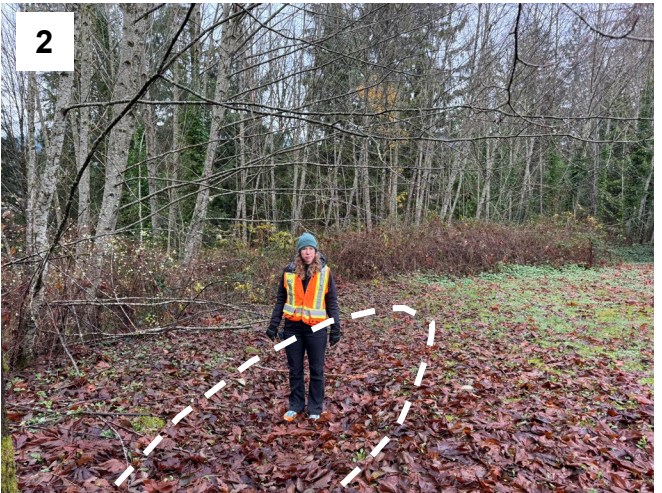
C-4

- 2005 Berkley landslide scarp re-vegetated with alders.
- Minor depression observed behind crest at north side of scarp (Photo 2). No signs of recent movement observed here at the time of inspection.

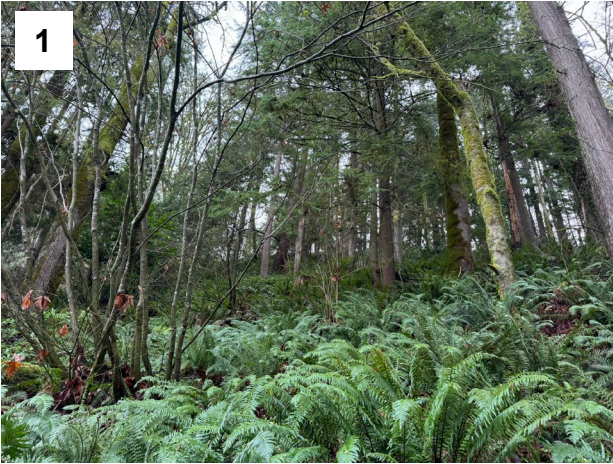
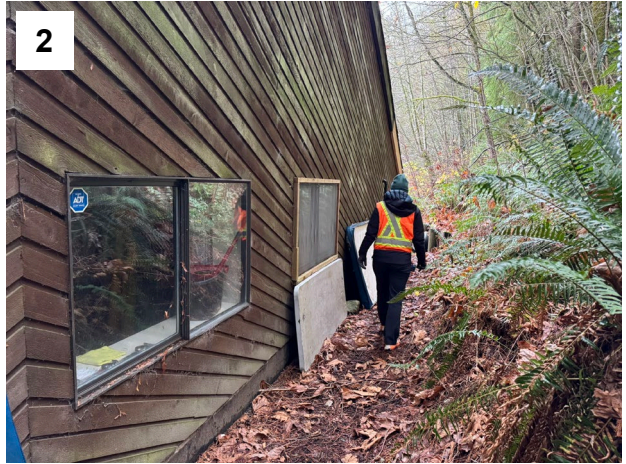
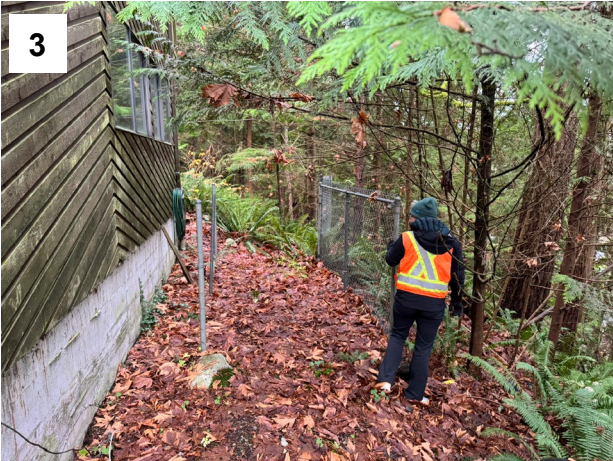
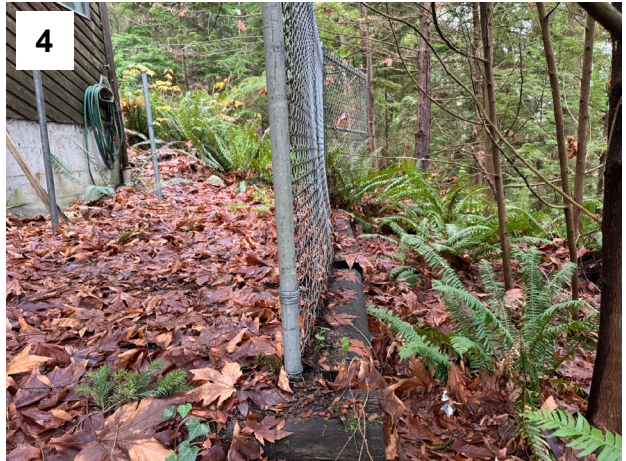
C-5

- Windows near ground level at the rear of the house (Photo 2).
- 0.4 m tall timber crib retaining wall located 2.5 m from the rear of the house and above 13 m tall slope (Photos 3, 4). Retaining wall is bowing downslope slightly. Building downslope of retaining wall is outside of 19° runout angle.

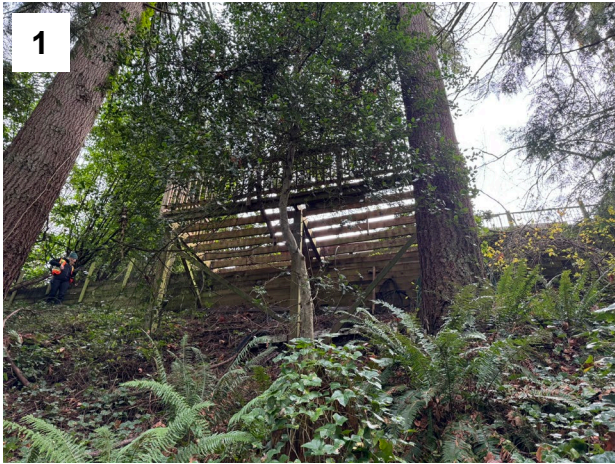
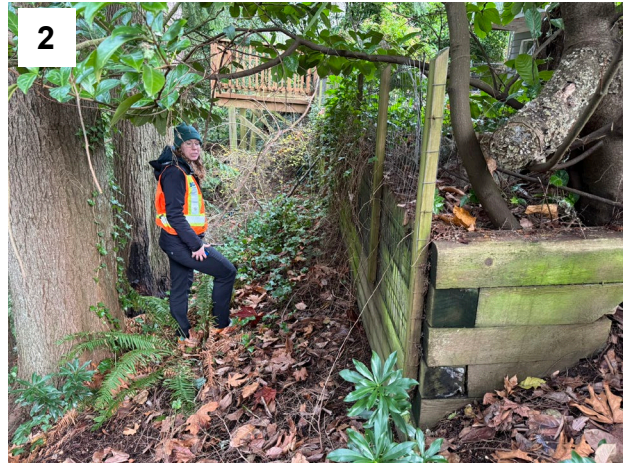
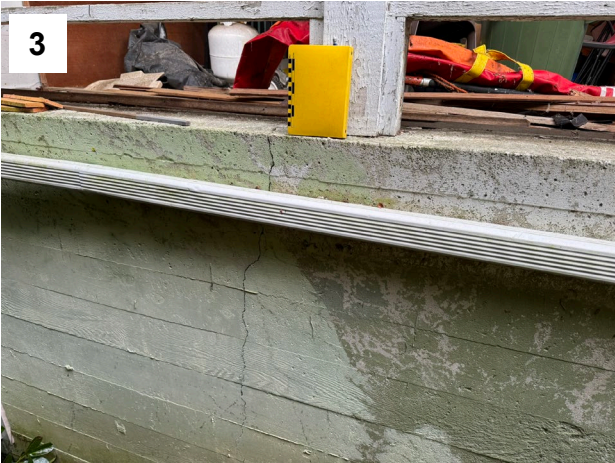
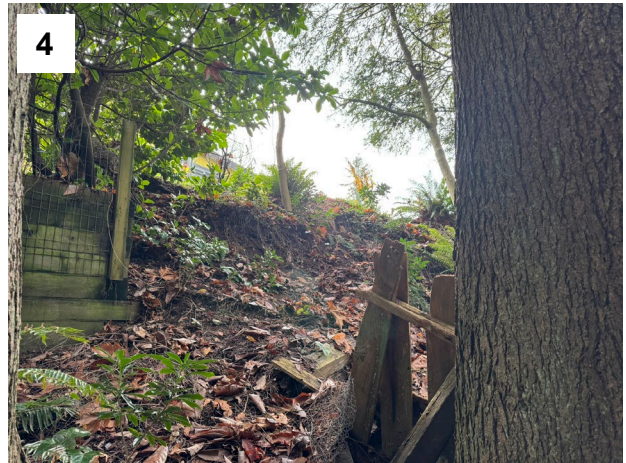
C-6

- Retaining wall in good overall condition at time of inspection (Photo 2). Some evidence of minor tilting and bowing.
- Large conifers on slope are straight.
- Vertical crack observed in building foundation (Photo 3).
- Loose exposed soil at south side of property, south of retaining wall (Photo 4).

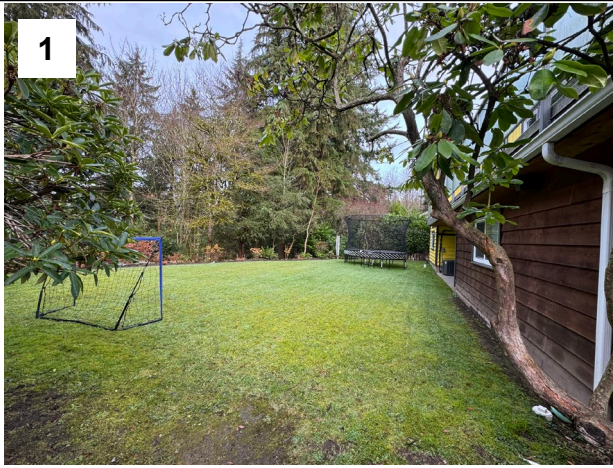
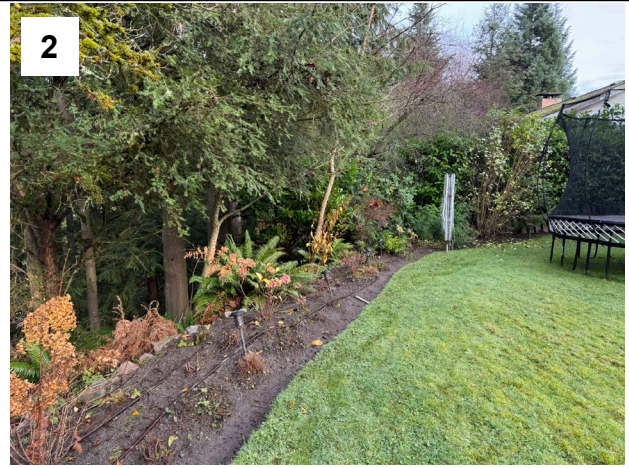
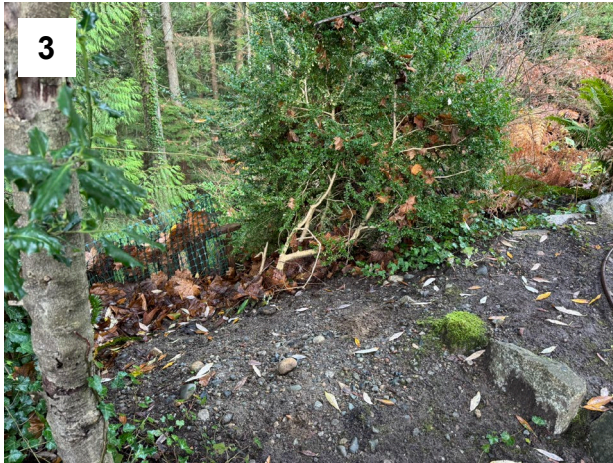
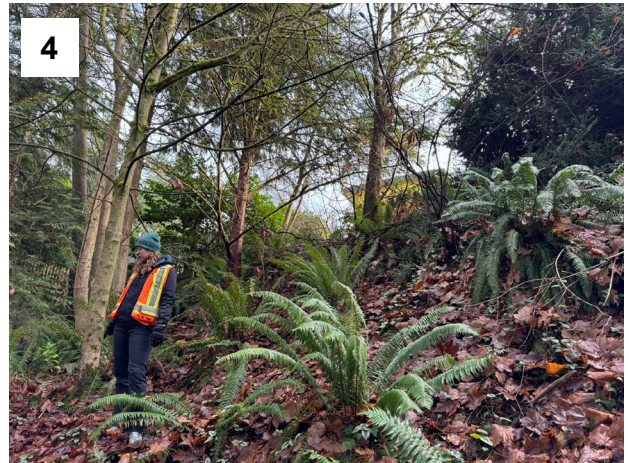
C-7

- Back yard is level (Photo 1). Small depression in grass near garden bed (Photo 2). Garden irrigation at the crest of slope (Photo 2).
- No retaining wall.
- Yard trimmings and loose fill (<0.5 m³) pushed over edge of slope (Photo 3).
- Less mature trees compared to slope below 2141 Berkley. Some pistol butted trees observed.

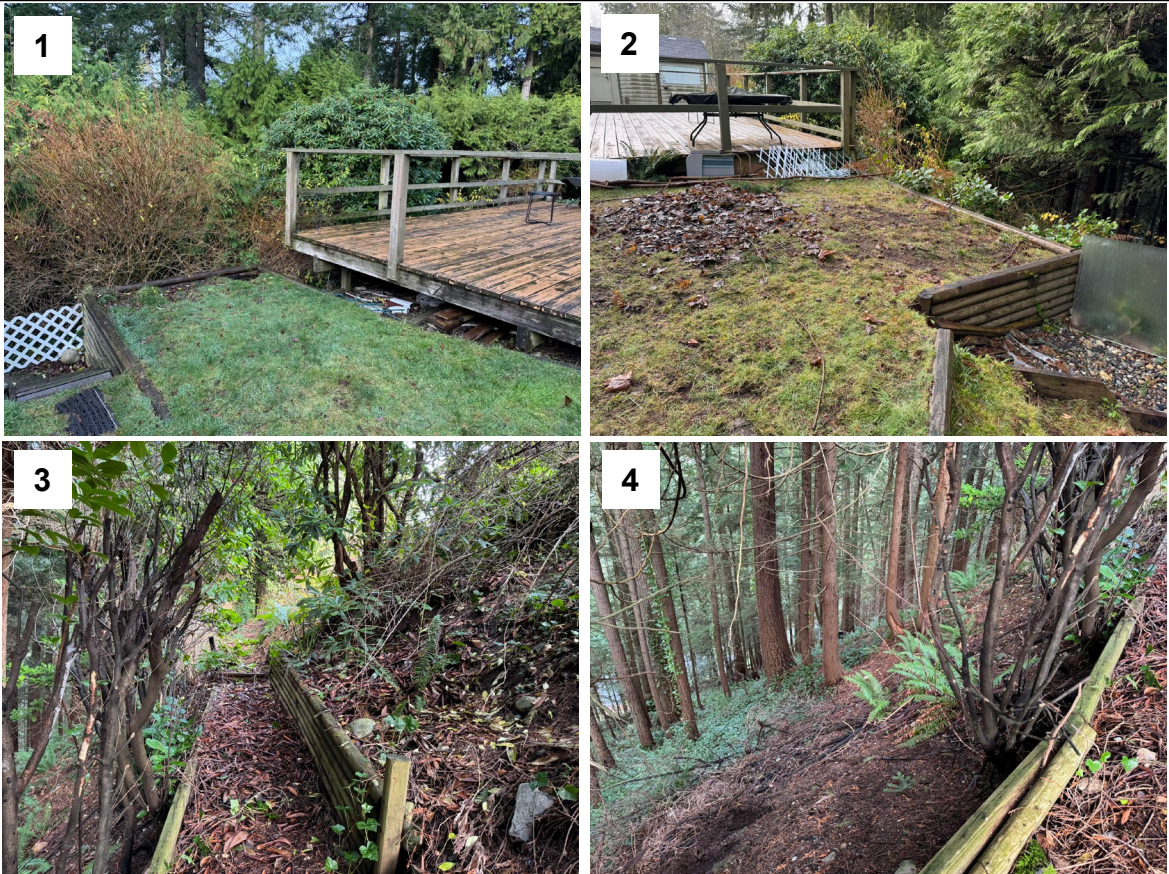
C-8

- Hot tub previously reported no longer there.
- Tiered timber crib retaining walls holding back garden beds in relatively good condition at time of inspection (Photo 3).
- Some pistol butted cedars observed on slope (Photo 4).

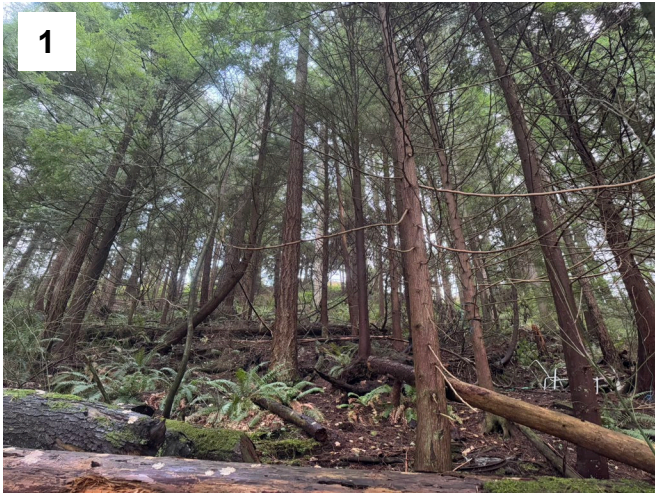
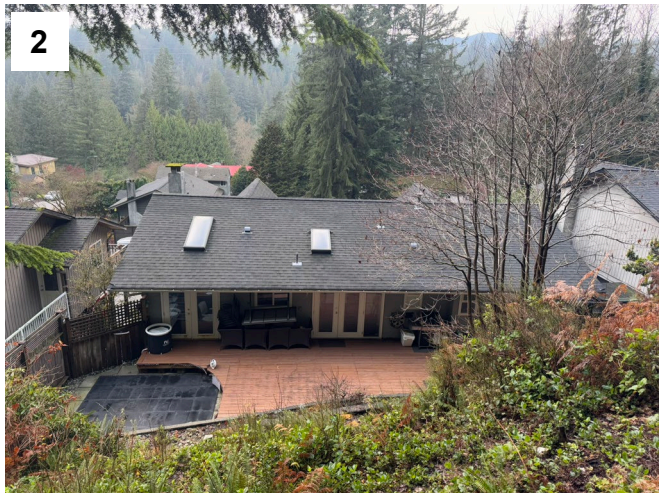
PREPARED BY: LCH	FIGURE TITLE: 2050 Rivergrove		
CHECKED BY: SZ	CLIENT: District of North Vancouver		
APPROVED BY: LCH	SCALE: N/A	PROJECT NO: 0404103	FIGURE NO: C-9

- BGC traversed slope above 2050 Rivergrove but did not enter backyard to observe condition of retaining wall.

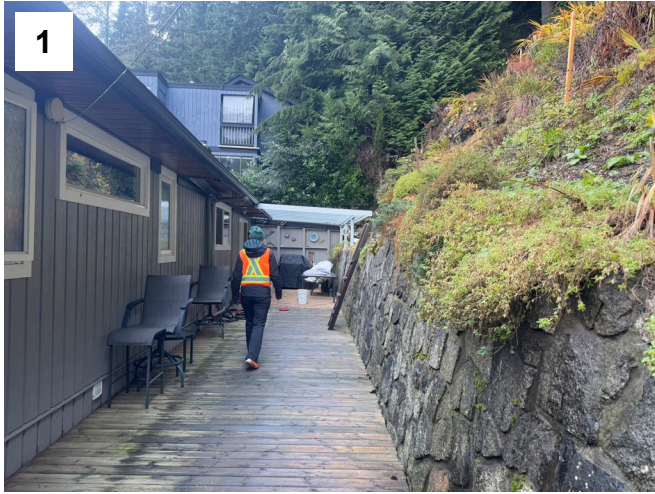
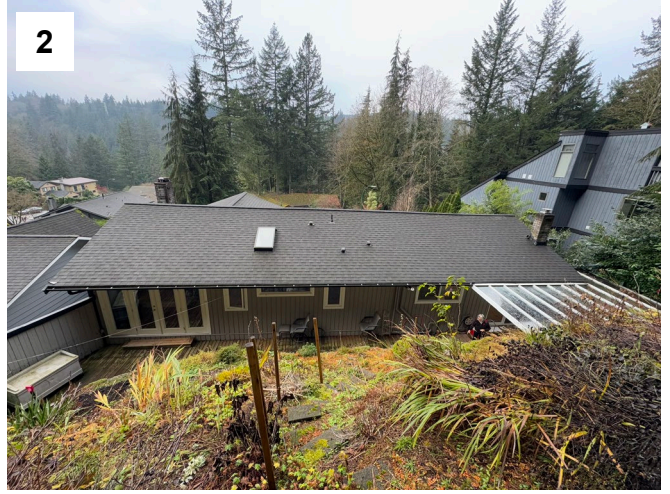
Observations	<ul style="list-style-type: none"> • Stone retaining wall in good condition (Photo 1). • House very close to base of slope.
---------------------	---

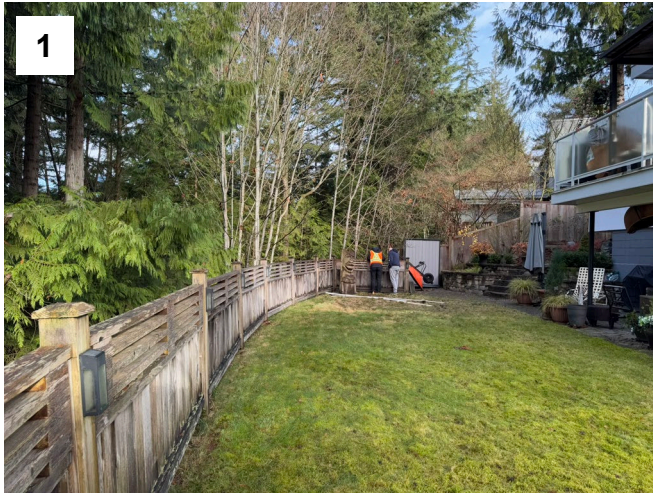
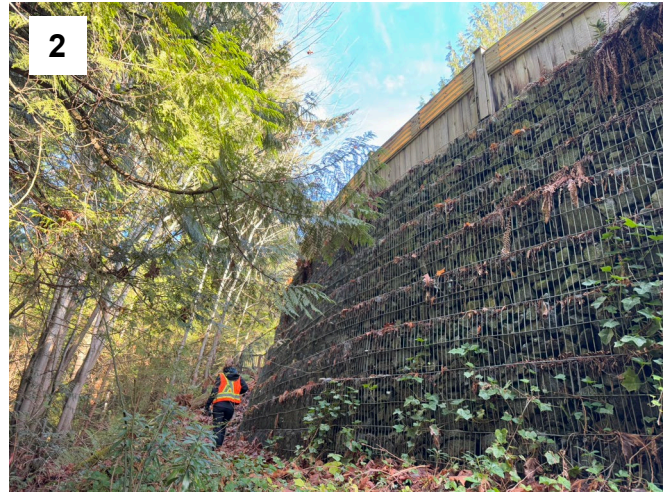
C-11

- Backyard supported with retaining wall (Photo 1). Fence at west side of backyard is tilted. Property owner acknowledged that the fence has never been straight.
- Approximately 4 m tall stepped gabion basket retaining wall with 0.5 m tall gabions (Photo 2). Property owner mentioned the gabion baskets were tied back with geogrid. Retaining wall appeared to be in good condition with no observed bulging or settling at the time of inspection.

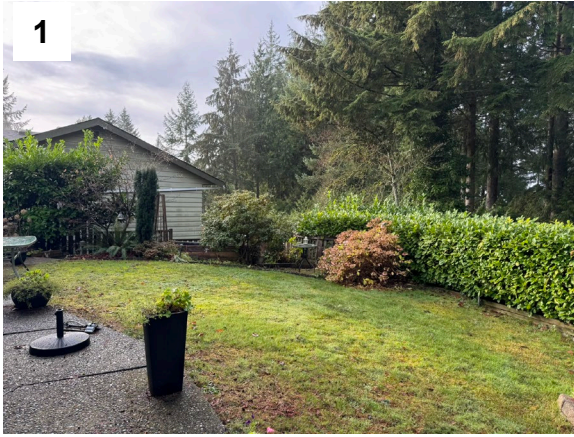
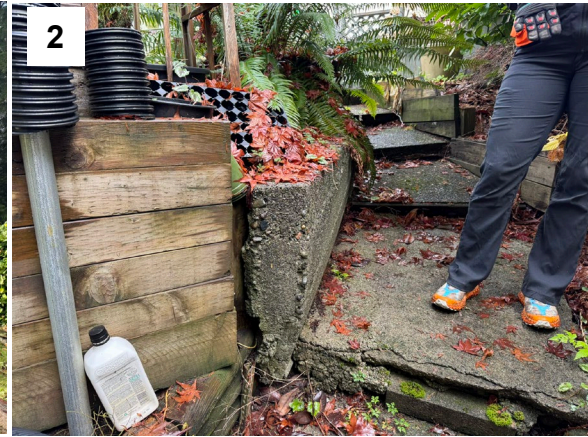
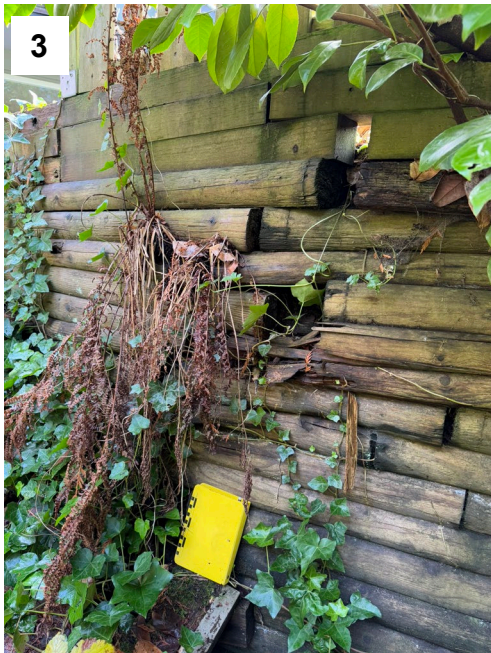
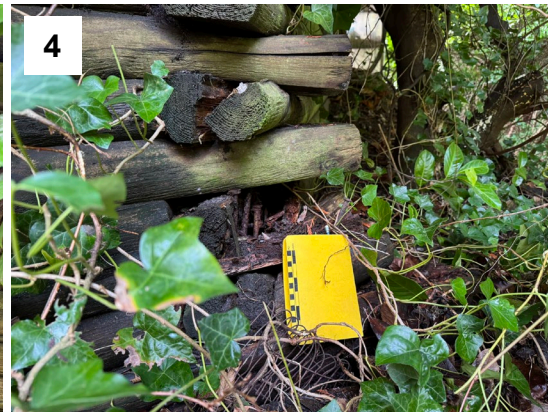
PREPARED BY: LCH	FIGURE TITLE: 2454 Hayseed		
CHECKED BY: SZ	CLIENT: District of North Vancouver		
APPROVED BY: LCH	SCALE: N/A	PROJECT NO: 0404103	FIGURE NO: C-12

Life-loss risk at these properties is elevated due to the proximity to the slope, slope height and angle, and the presence of a deteriorating retaining wall at an upslope property (2454 Hayseed Close). BGC also identified properties downslope of 2360 Carman Place (1788, 1802 Riverside Drive) which are near the risk tolerance threshold and within the range of uncertainty of the analysis. BGC recommends that the DNV work with the property owners at these locations to inform them of the risk levels and to develop risk management approaches. At 2454 Hayseed Close, BGC recommends that the retaining wall is replaced with an appropriately designed structure reviewed by a Qualified Professional to ensure the design will achieve the required level of risk reduction and appropriate factor of safety. At the time of writing, BGC understands that work is underway to replace the retaining wall.

Observations	<ul style="list-style-type: none"> • Backyard slopes toward crest (Photo 1). • Concrete retaining wall <1 m tall at south side of property (Photo 2). Steps adjacent to concrete retaining wall are tilted downslope. • Timber crib retaining wall at north end of backyard. Some logs in structure are rotting and/or splitting. Downslope face shows minimal signs of differential movement or tilting; however, joints at corners show separation downslope (Photos 3, 4).
---------------------	---

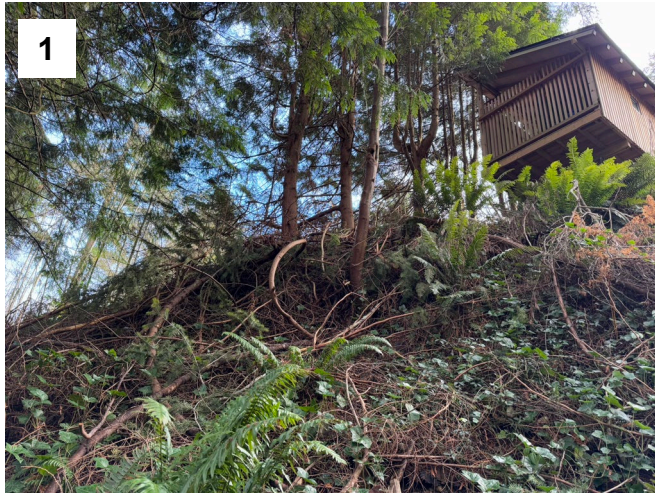
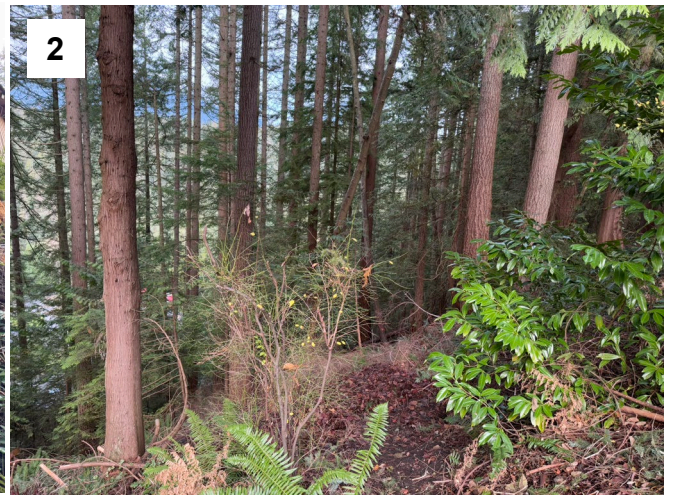
Observations	<ul style="list-style-type: none"> • Yard waste and cuttings observed over slope crest. • No retaining wall. Relatively gentle slope at crest.
---------------------	--

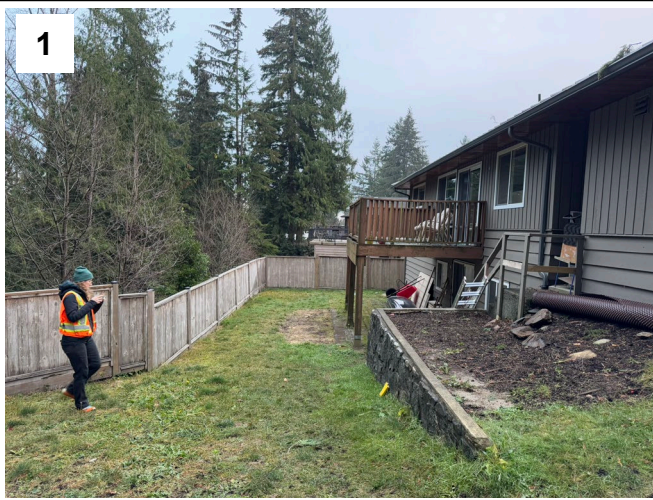
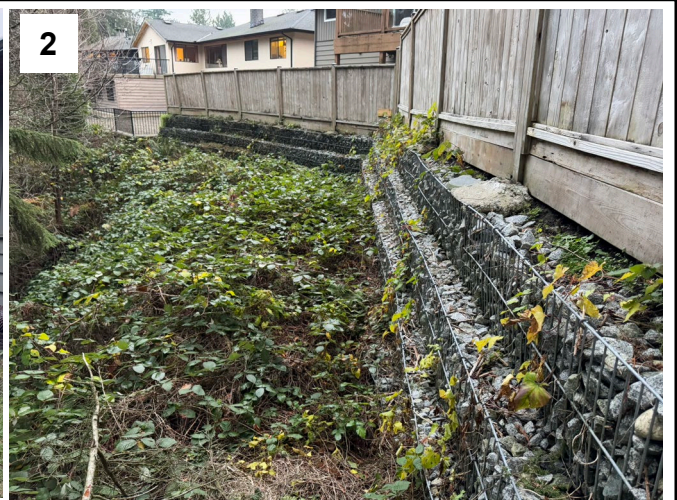
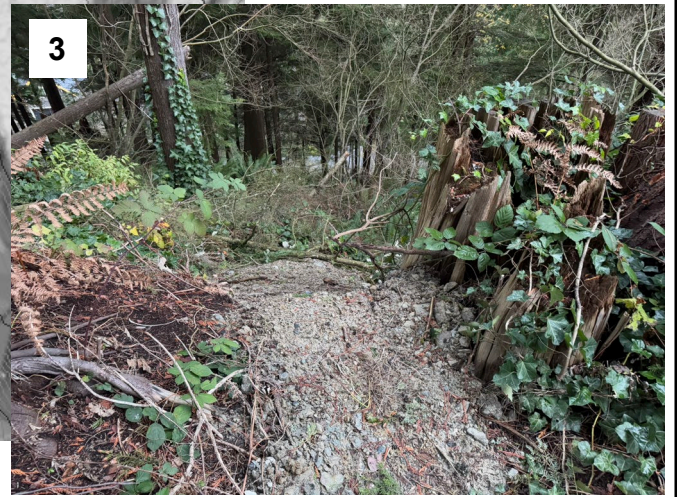
C-14

- Gabion basket retaining wall appears to be in good condition (Photo 2)
- Approximately 0.5 m^3 of saturated material (silt and gravel, some clay) placed over the crest of slope at north end of property (Photo 3).

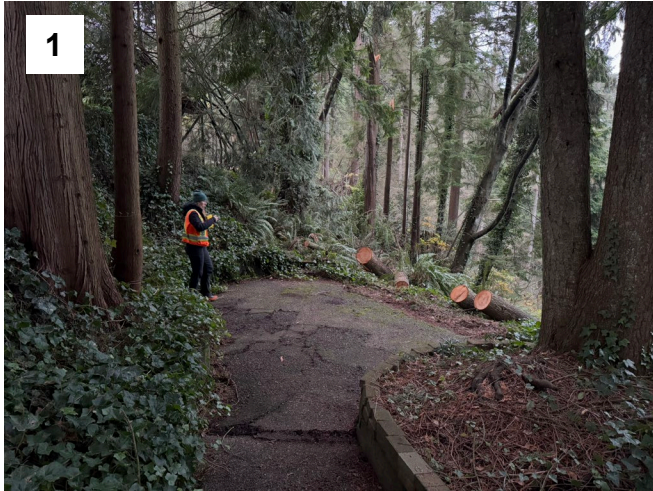
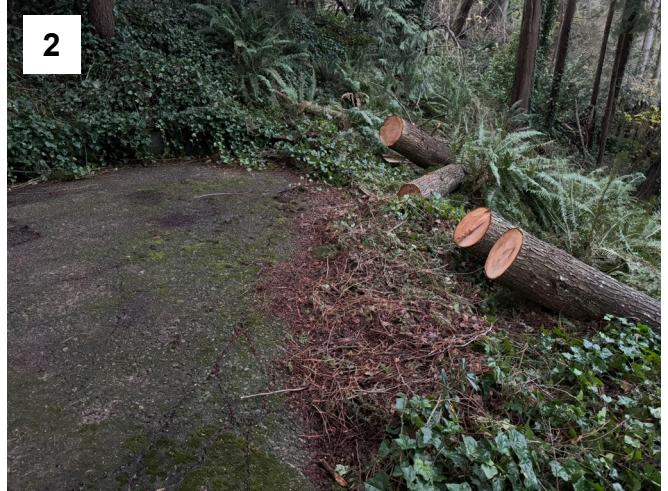
- Concrete seating area downslope of backyard, sloping outward (Photo 1). Cracks observed in concrete. No retaining wall observed.
- Trees and yard cuttings observed deposited over edge of slope (Photos 1, 2).
