Landslide Risk Assessment 2026 Update

Project 0404103
Document Rev 0

District of North Vancouver
355 West Queens Road
North Vancouver, BC V7N 4N5

Landslide Risk Assessment – 2026 Update

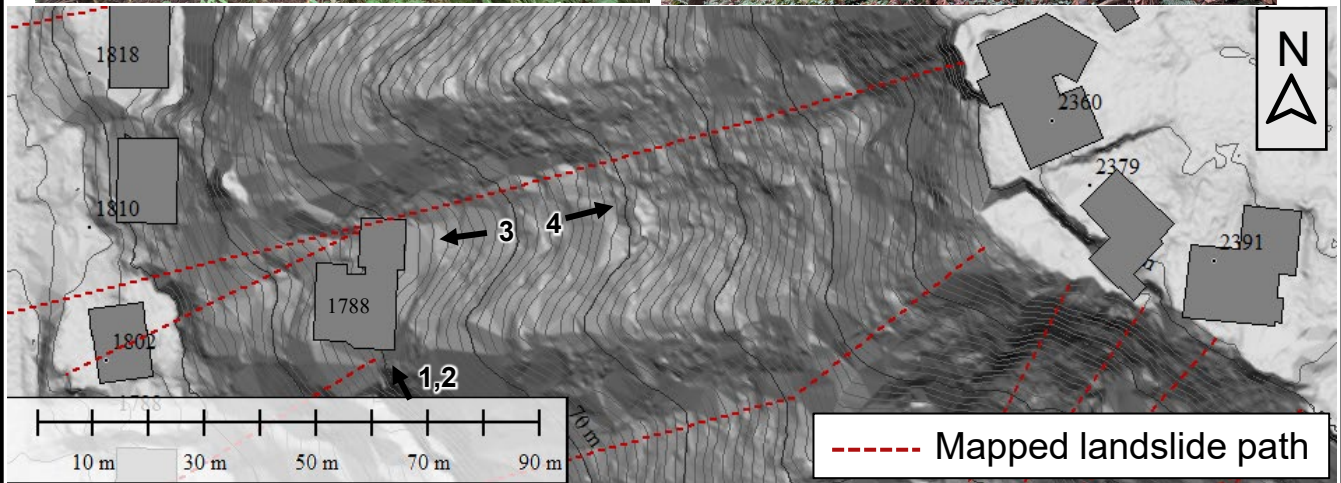
C-2

- Cracks observed parallel to slope in driveway. Existing retaining wall at driveway in robust condition.
- Building in natural gully that includes the 1979 slide path. Large conifers observed in gully.
- Northeast corner of building exposed to landslides from 2360 Carman (Photo 3). Southern portion of building footprint protected by ridgeline.

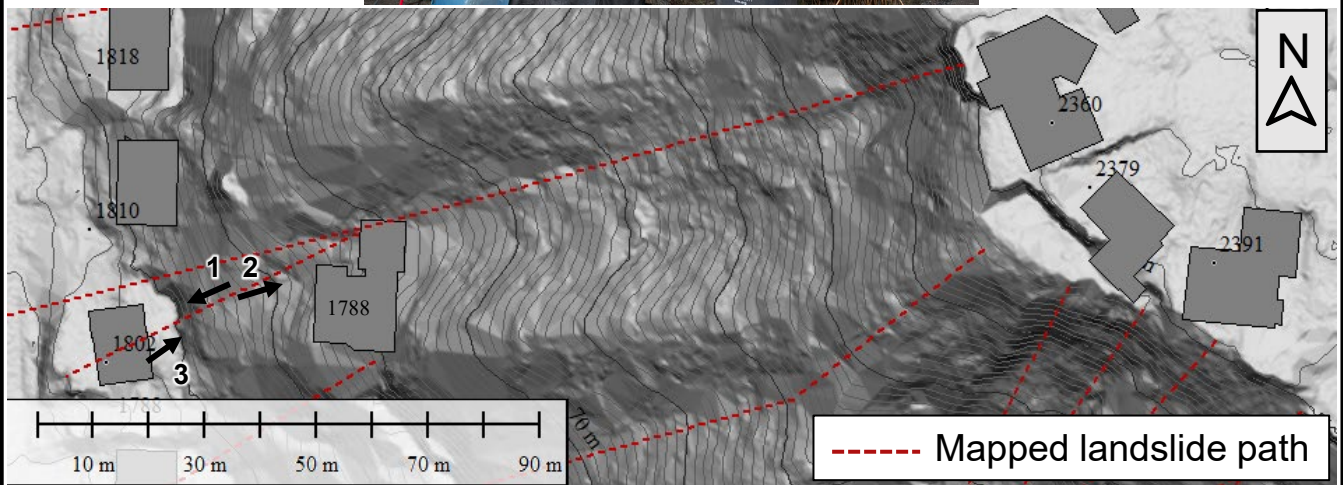
C-3

- Property downslope of 1788 Riverside. Gentler slope upslope of retaining wall.
- Landowner reported having a test pit completed in upslope area and indicated dense material was observed approximately 18 inches below ground (BGC does not have access to log to confirm).
- Landowner reported that stone retaining wall seeps in heavy rain.

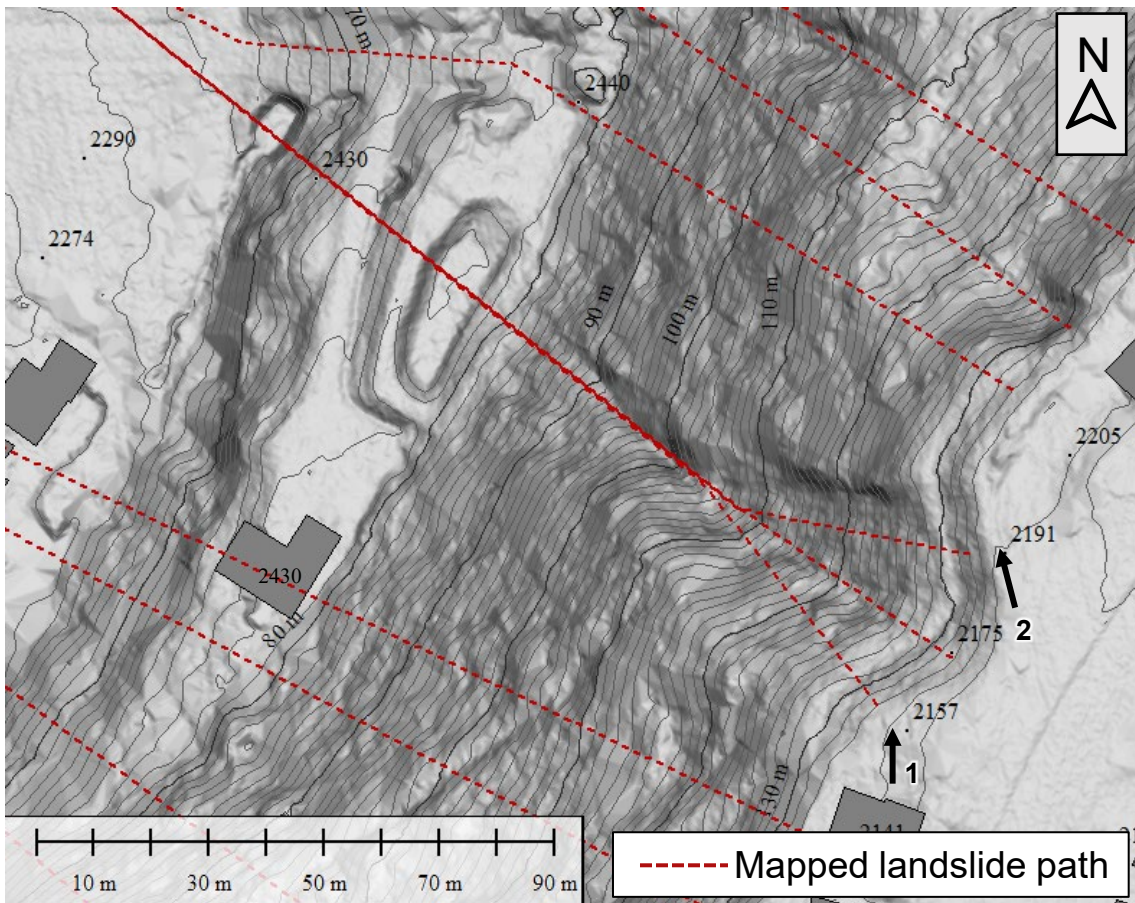
C-4

- 2005 Berkley landslide scarp re-vegetated with alders.
- Minor depression observed behind crest at north side of scarp (Photo 2). No signs of recent movement observed here at the time of inspection.

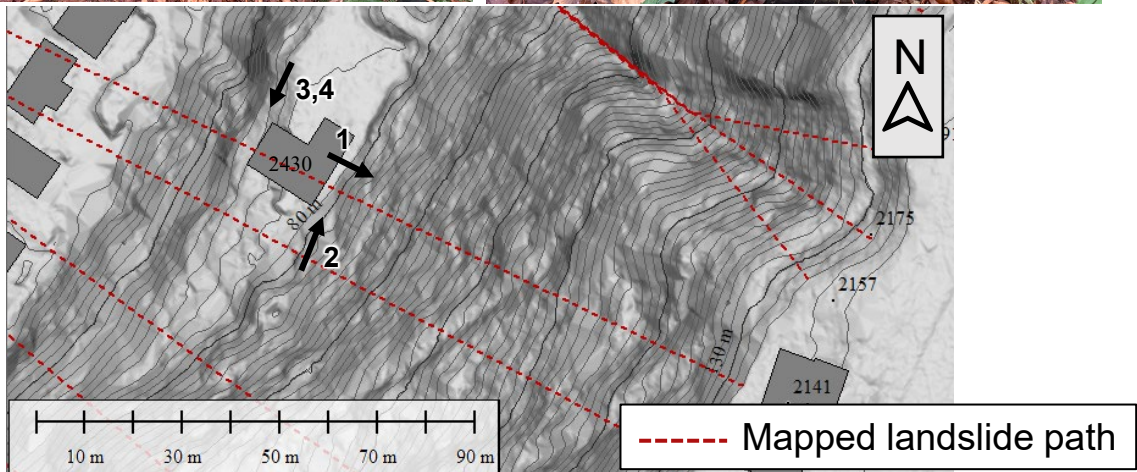
C-5

- Windows near ground level at the rear of the house (Photo 2).
- 0.4 m tall timber crib retaining wall located 2.5 m from the rear of the house and above 13 m tall slope (Photos 3, 4). Retaining wall is bowing downslope slightly. Building downslope of retaining wall is outside of 19° runout angle.

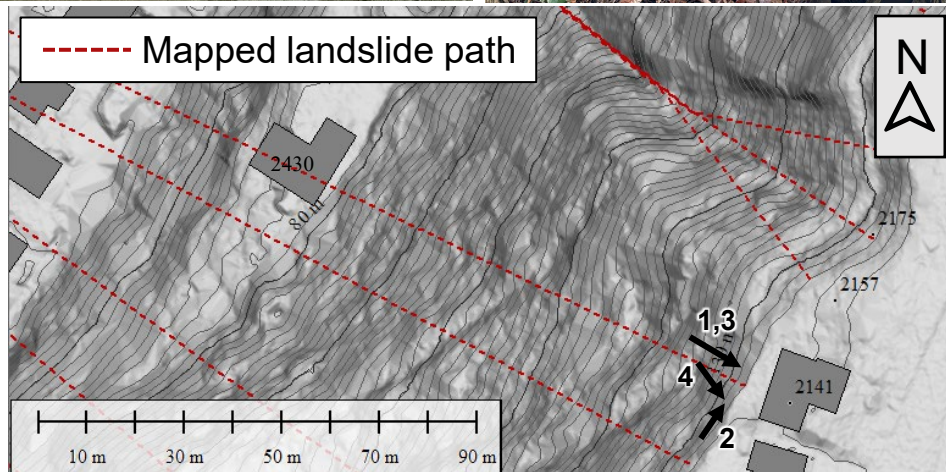
C-6

- Retaining wall in good overall condition at time of inspection (Photo 2). Some evidence of minor tilting and bowing.
- Large conifers on slope are straight.
- Vertical crack observed in building foundation (Photo 3).
- Loose exposed soil at south side of property, south of retaining wall (Photo 4).

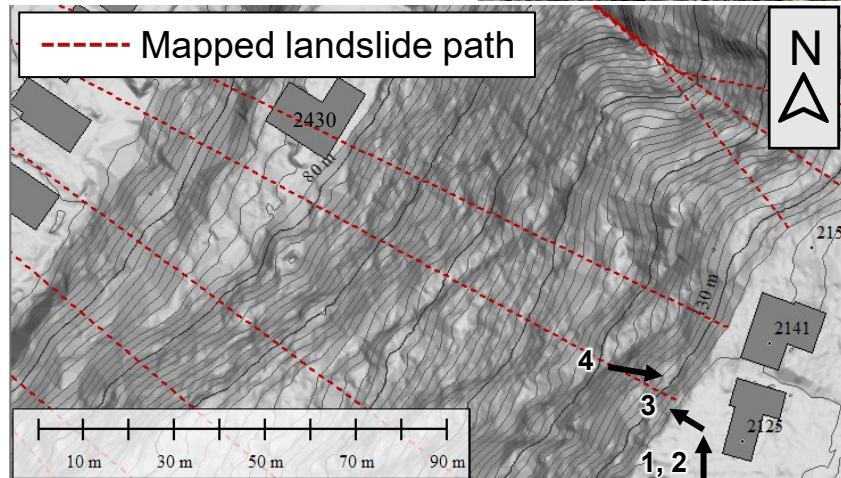
C-7

- Back yard is level (Photo 1). Small depression in grass near garden bed (Photo 2). Garden irrigation at the crest of slope (Photo 2).
- No retaining wall.
- Yard trimmings and loose fill (<0.5 m³) pushed over edge of slope (Photo 3).
- Less mature trees compared to slope below 2141 Berkley. Some pistol butted trees observed.

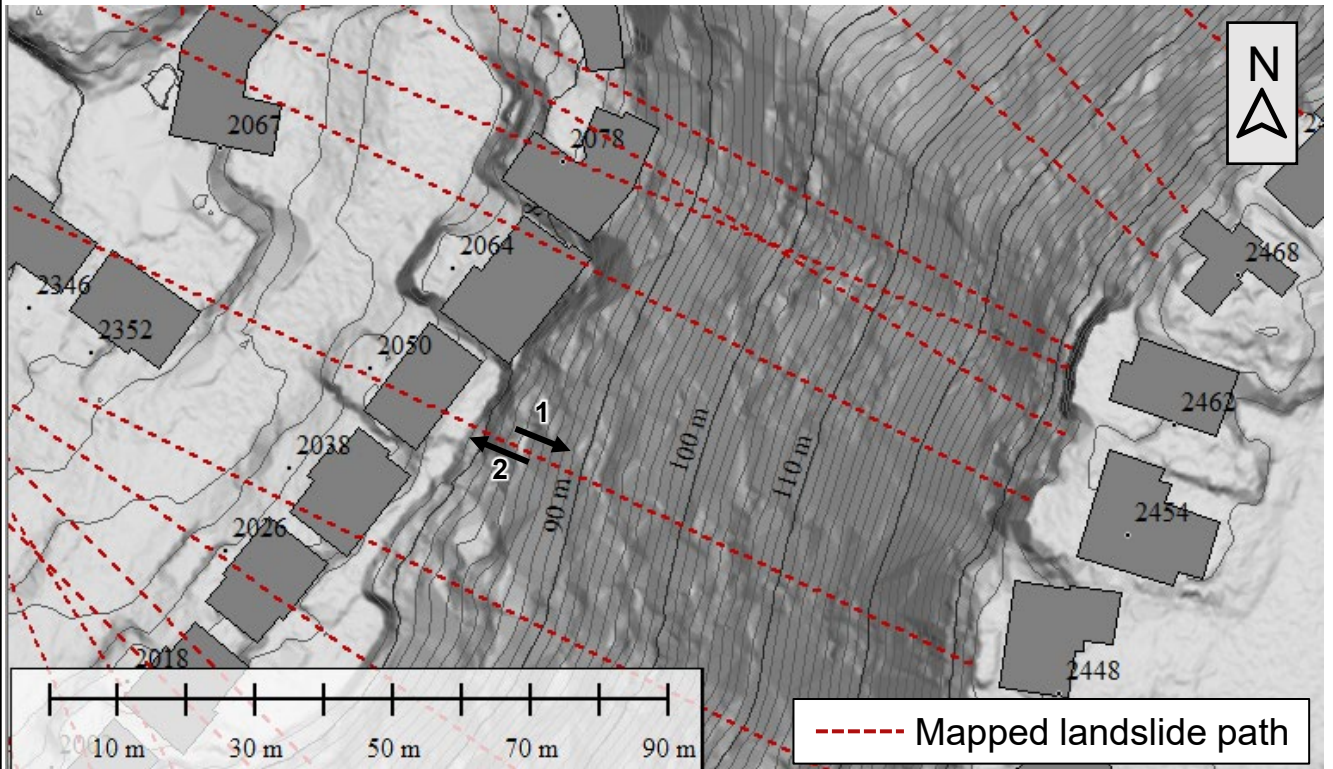
- BGC traversed slope above 2050 Rivergrove but did not enter backyard to observe condition of retaining wall.

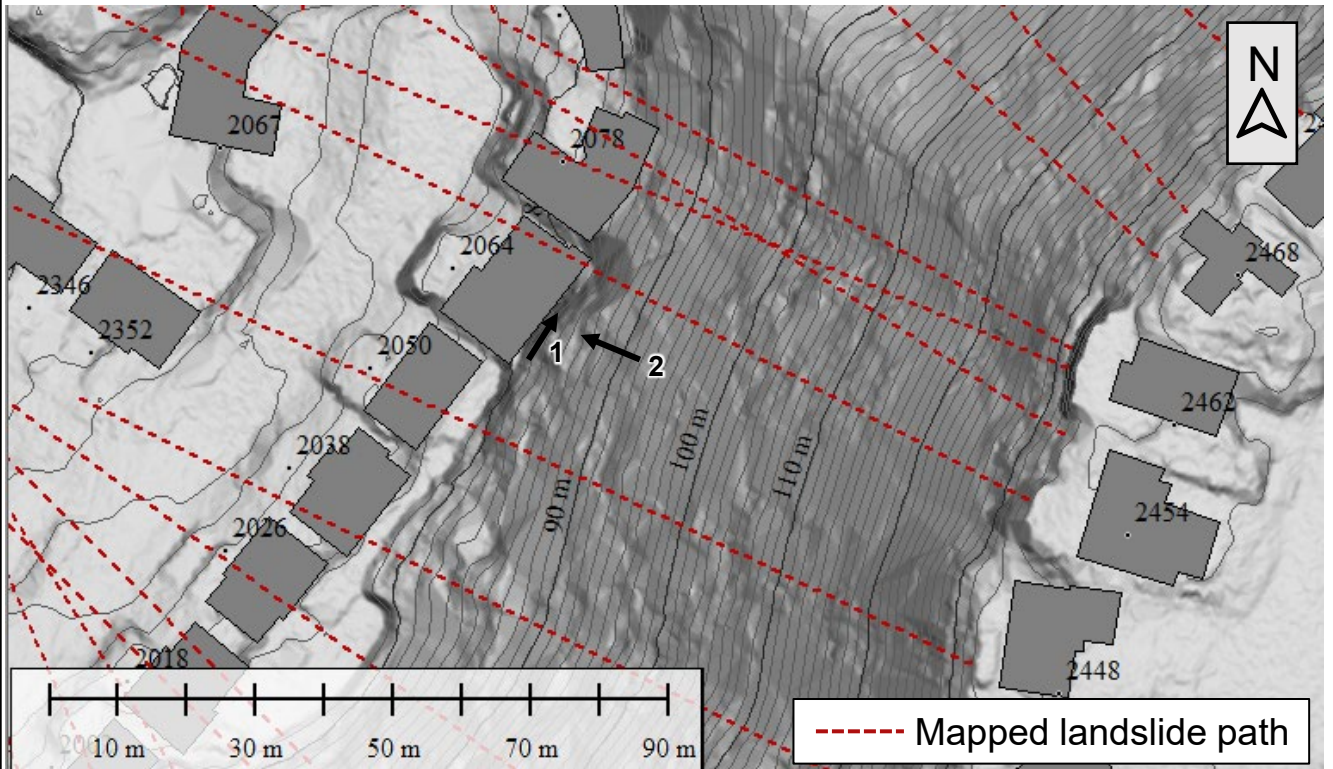
Observations	<ul style="list-style-type: none"> • Stone retaining wall in good condition (Photo 1). • House very close to base of slope.
---------------------	---

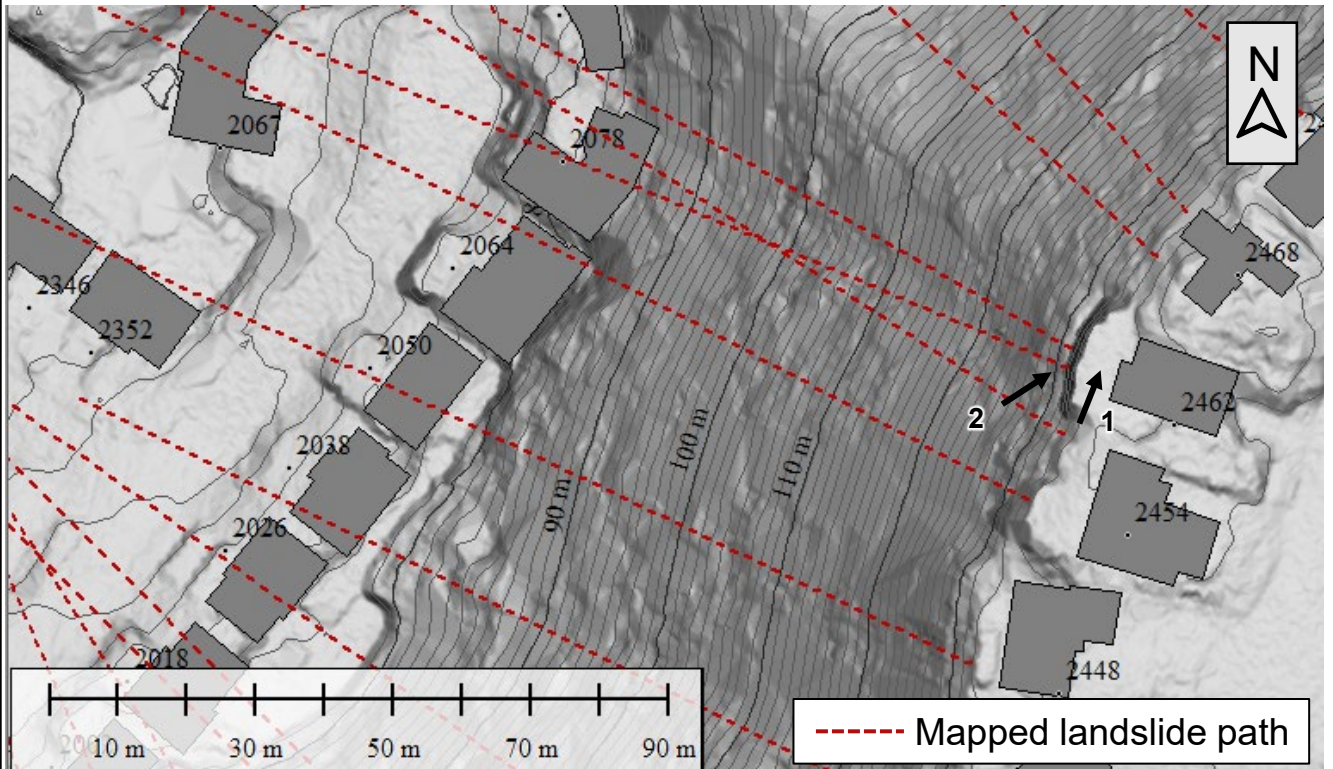
C-11

- Backyard supported with retaining wall (Photo 1). Fence at west side of backyard is tilted. Property owner acknowledged that the fence has never been straight.
- Approximately 4 m tall stepped gabion basket retaining wall with 0.5 m tall gabions (Photo 2). Property owner mentioned the gabion baskets were tied back with geogrid. Retaining wall appeared to be in good condition with no observed bulging or settling at the time of inspection.

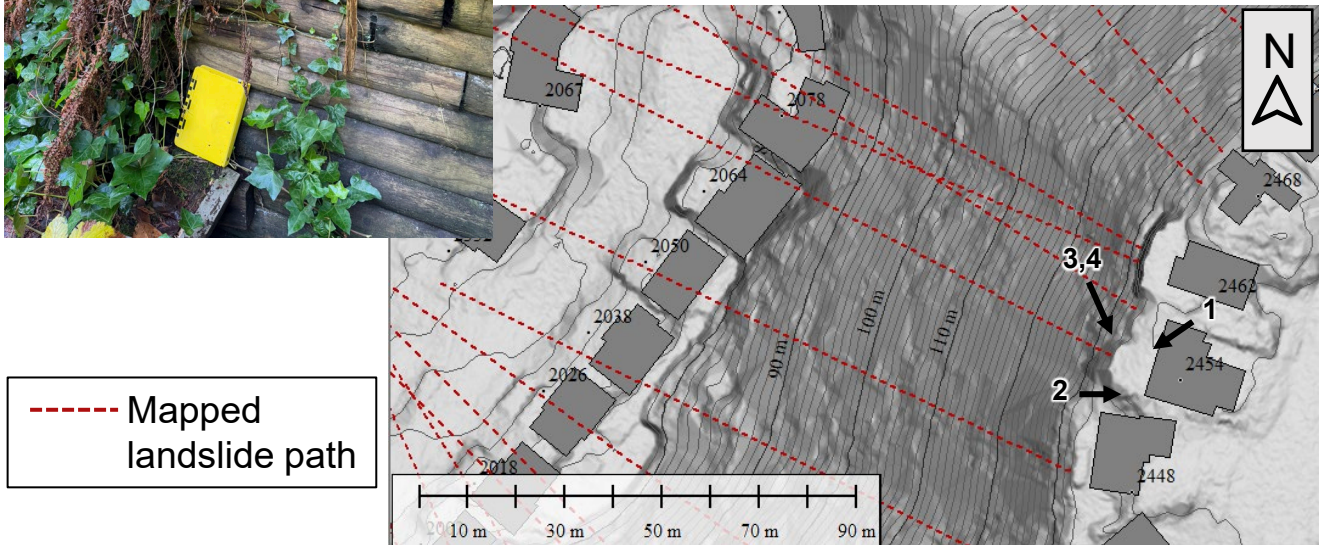
Life-loss risk at these properties is elevated due to the proximity to the slope, slope height and angle, and the presence of a deteriorating retaining wall at an upslope property (2454 Hayseed Close). BGC also identified properties downslope of 2360 Carman Place (1788, 1802 Riverside Drive) which are near the risk tolerance threshold and within the range of uncertainty of the analysis. BGC recommends that the DNV work with the property owners at these locations to inform them of the risk levels and to develop risk management approaches. At 2454 Hayseed Close, BGC recommends that the retaining wall is replaced with an appropriately designed structure reviewed by a Qualified Professional to ensure the design will achieve the required level of risk reduction and appropriate factor of safety. At the time of writing, BGC understands that work is underway to replace the retaining wall.

Observations	<ul style="list-style-type: none"> • Backyard slopes toward crest (Photo 1). • Concrete retaining wall <1 m tall at south side of property (Photo 2). Steps adjacent to concrete retaining wall are tilted downslope. • Timber crib retaining wall at north end of backyard. Some logs in structure are rotting and/or splitting. Downslope face shows minimal signs of differential movement or tilting; however, joints at corners show separation downslope (Photos 3, 4).
---------------------	---

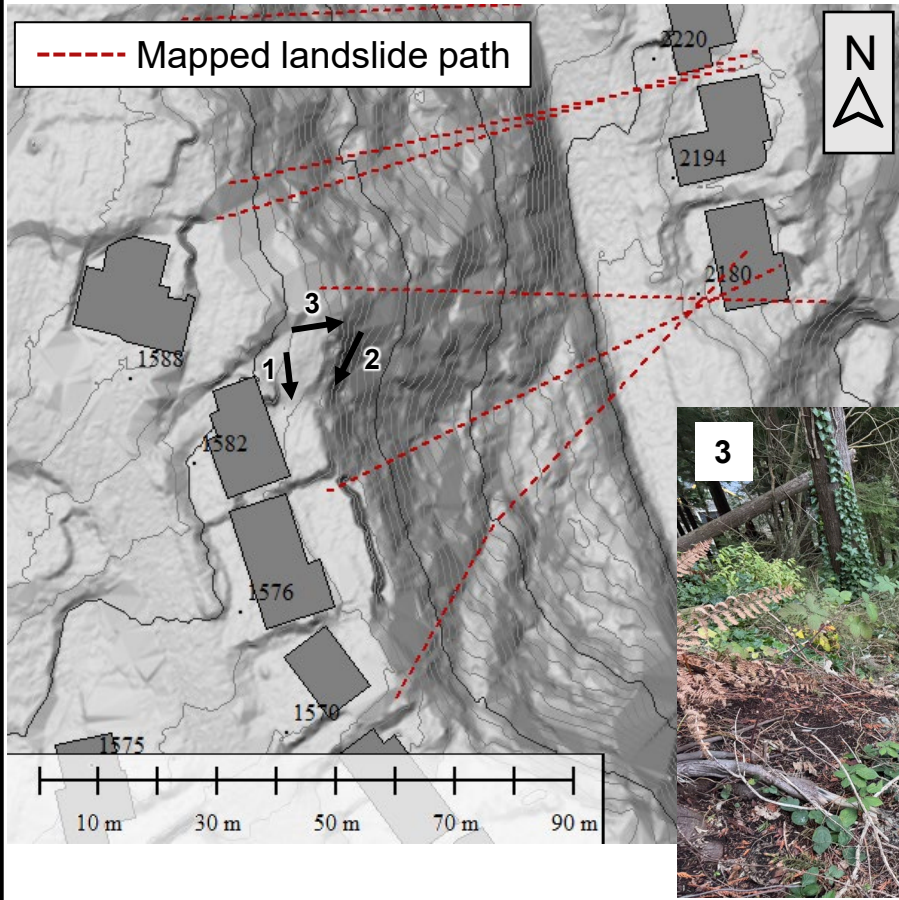
- Gabion basket retaining wall appears to be in good condition (Photo 2)
- Approximately 0.5 m^3 of saturated material (silt and gravel, some clay) placed over the crest of slope at north end of property (Photo 3).

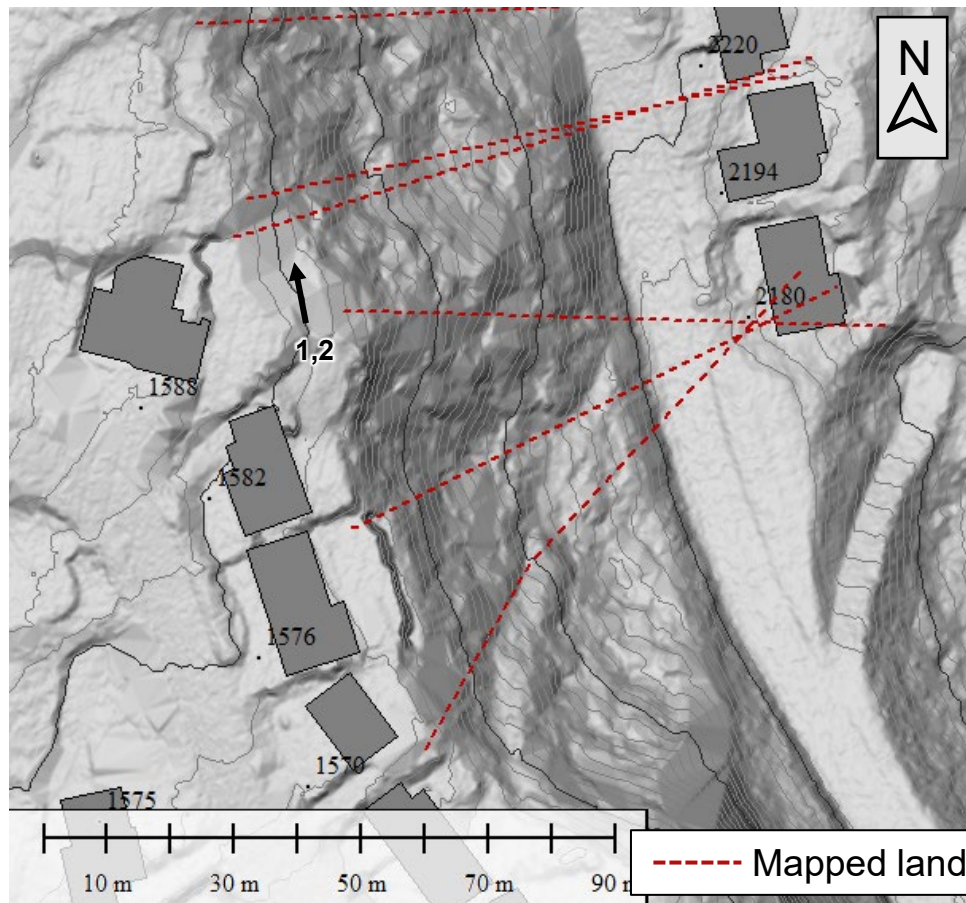
C-14

- Concrete seating area downslope of backyard, sloping outward (Photo 1). Cracks observed in concrete. No retaining wall observed.
- Trees and yard cuttings observed deposited over edge of slope (Photos 1, 2).
